E 16	Product/assembly/test step	
	Vehicle/engine

A1

Trouble-shooting program

Danger of Accident on Semi-conductor Ignition Systems

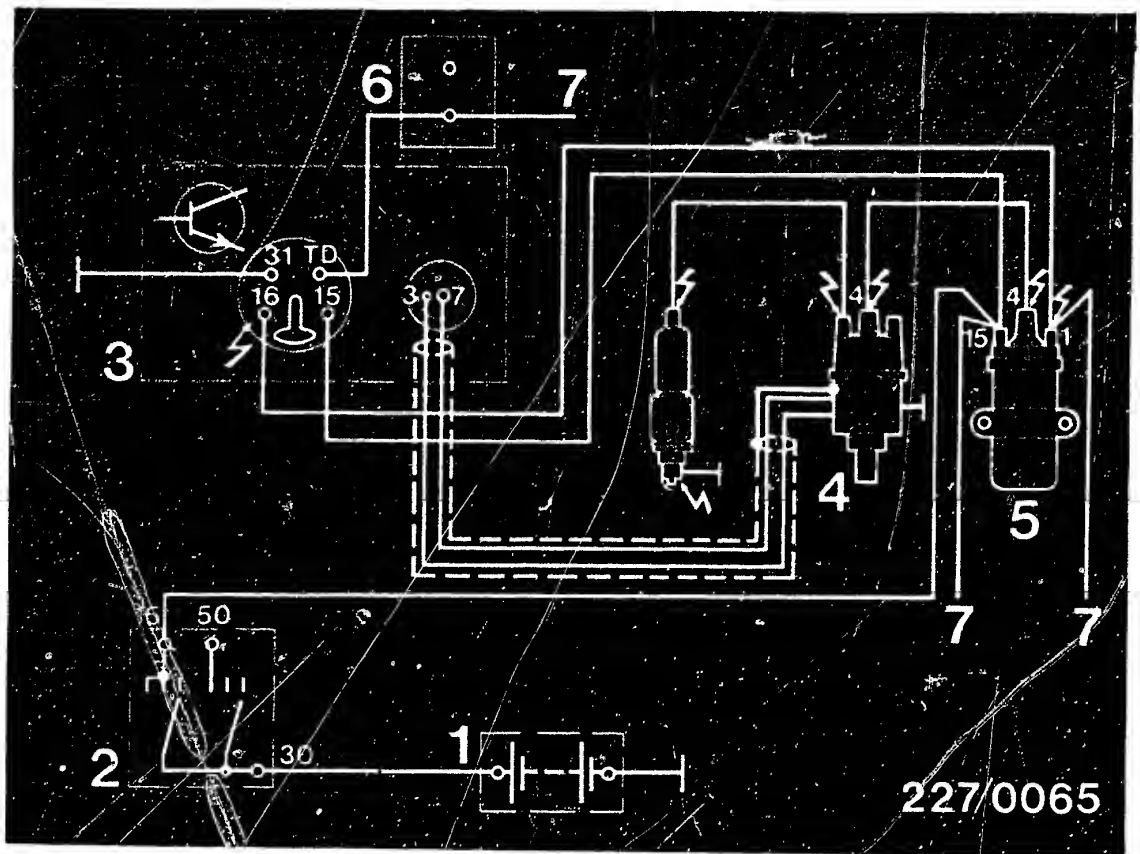
Electrical terminal diagram

⚡ = Dangerous voltages (400 V - 25 KV)

The dangerous locations are marked with danger arrows taking the example of the terminal diagram of an electronic ignition system.

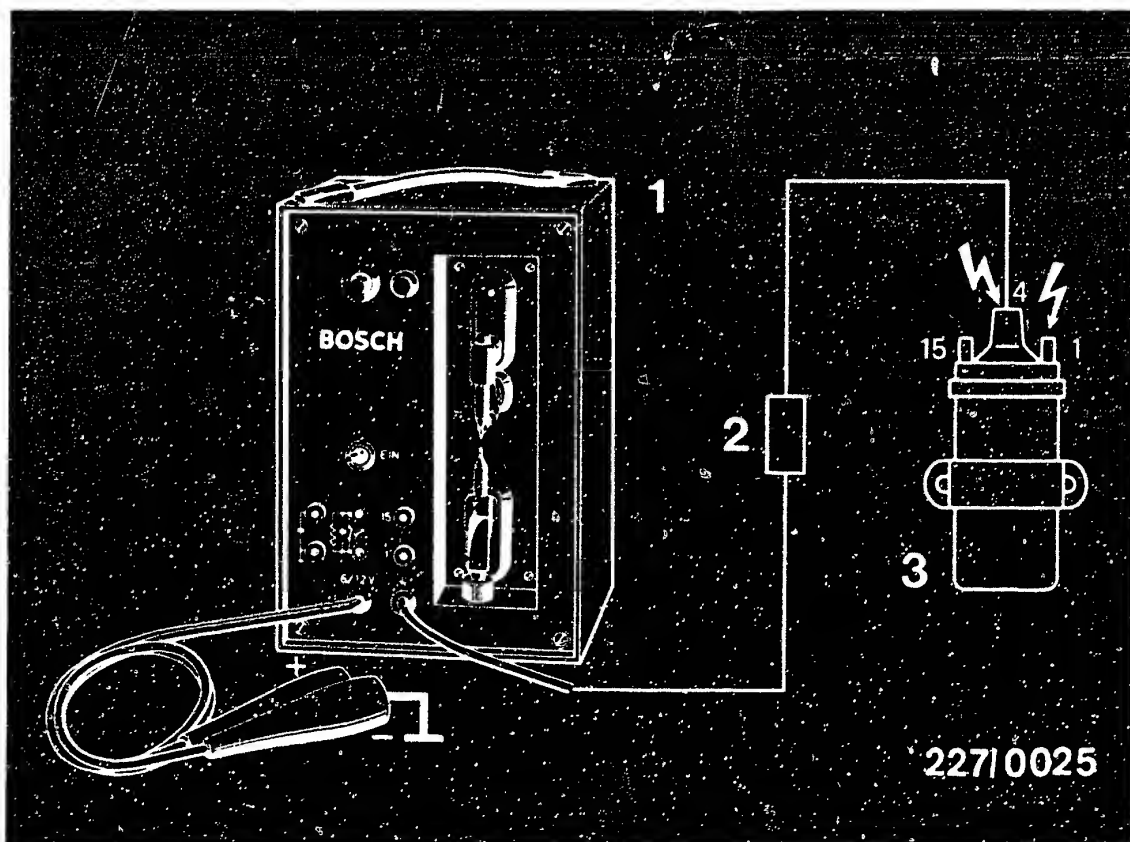
= Dangerous voltages (400 V - 25 kV)

- In order to prevent the trigger box from being irreparably damaged, when using a spark gap, an interference-suppression resistor of at least 2 k Ω must be connected between the spark gap and ignition coil terminal 4, e.g. sleeve-type suppressor (5 k Ω) 0 356 500 001.
- In the case of ignition distributors with engine-speed limitation the ignition distributor side terminal 4 must have 1 k Ω interference suppression. Operation without interference suppression will lead to the destruction of the trigger box.

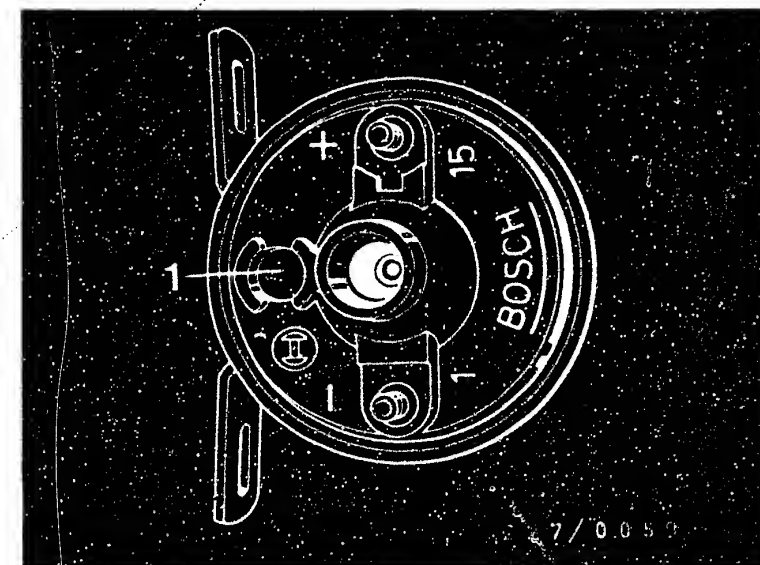
1 = Plug

Visual examination: Remove protective cap from ignition coil and check whether plug (see illustration) is in position and whether any sealing compound has escaped.

Plug in position? No sealing compound escaped?

1. If plug is not in position and/or sealing compound has escaped, replace trigger box and ignition coil.

2. If resistance values are not O.K., replace ignition coil.

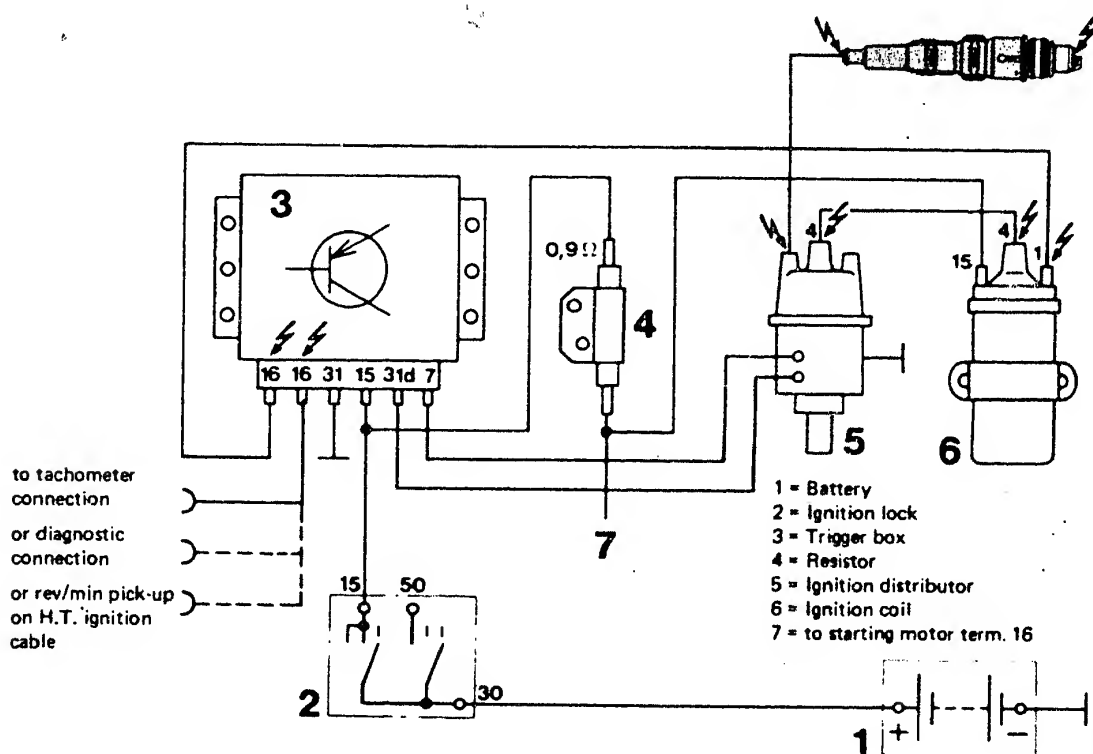
Terminal diagram

Below is a typical terminal diagram of a semi-conductor ignition system, the danger points are marked with red high-voltage arrows. We would point out that all semi-conductor ignition systems, even the older ones, are to be regarded as dangerous in the sense as defined by this bulletin.

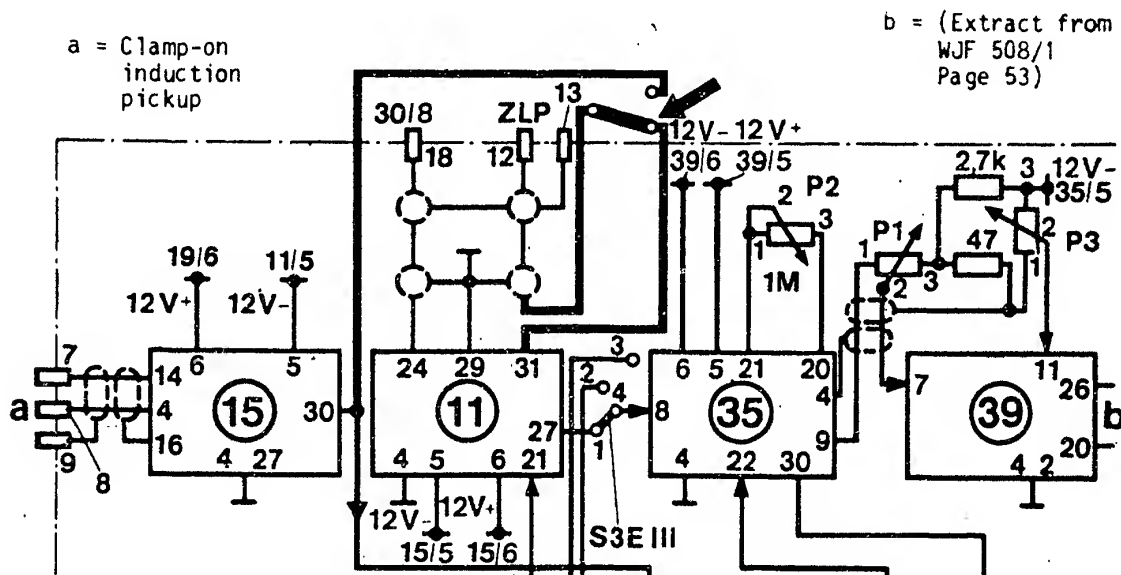
Remove the line of the ZLP* from pin 31 of printed board 11 (coupling stage) and connect to pin 30 of printed board 15 (pulse shaper stage) via a switch with change-over contact (e.g. 0 341 500 803). In addition, a new line must be connected from pin 31 of printed board 11 to the other contact of the switch with change-over contact. Arrow points to switch with change-over contact.

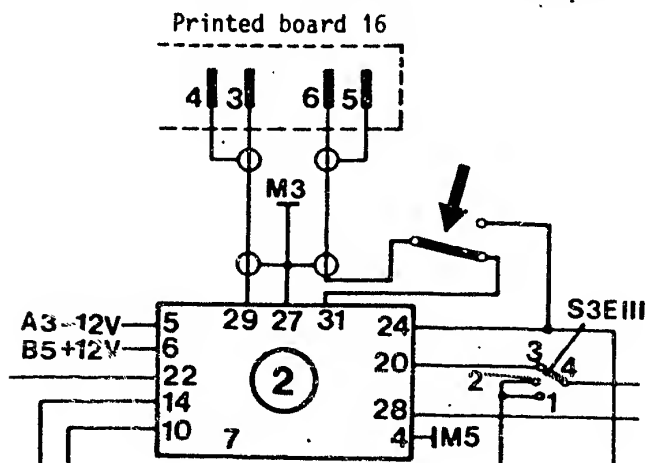
EFAW 214 B

Remove the line from terminal 6 of printed board 16 to pin 31 of printed board 2 (coupling stage) and connect to pin 24 of the same printed board via a switch with change-over contact (e.g. 0 341 500 803). In addition, a new line must be connected from pin 31 of printed board 2 to the other contact of the switch with change-over contact. Arrow points to switch with change-over contact.
